Sterling Woods, LLC

February 5, 2025 • Port Jefferson Station, NY

FULL RESERVE STUDY

Sterling Woods, LLC
Port Jefferson Station, New York

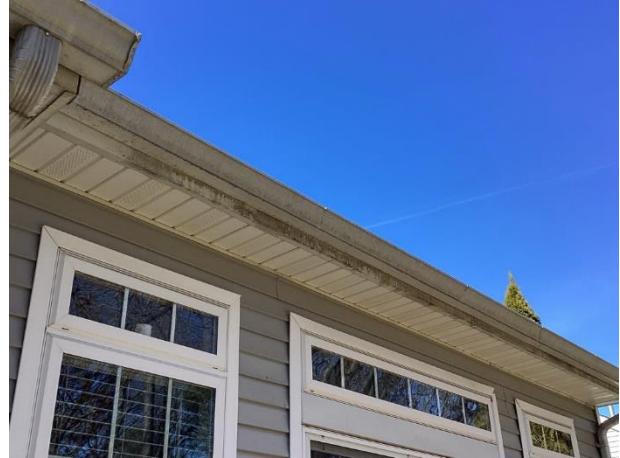
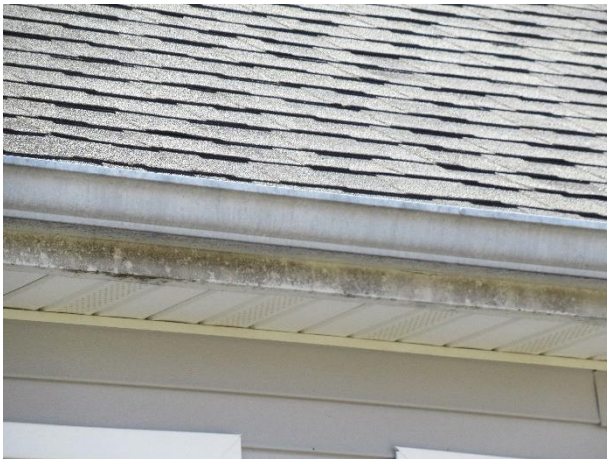
Condition: Good to fair overall with stains and general deterioration evident; Management and the Board report issues with the drainage capacity at the undersized gutters and downspouts.

Stains due to undersized gutters

The Association should plan to coordinate the replacement of gutters and downspouts with the adjacent roofs. This will result in the most economical unit price and minimize the possibility of damage to other roof components as compared to separate replacements.

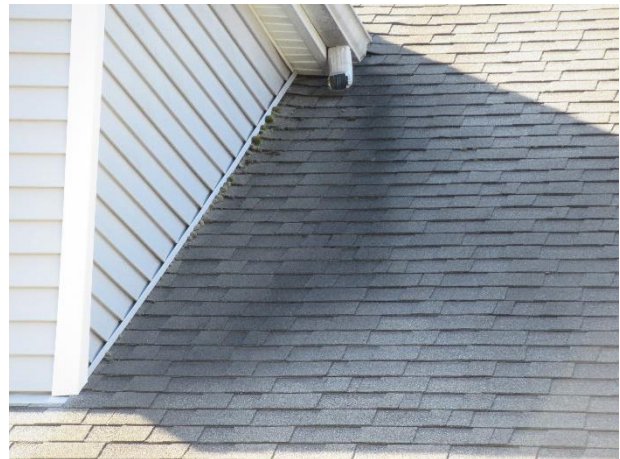
Example of downspout discharging water directly onto lower roof

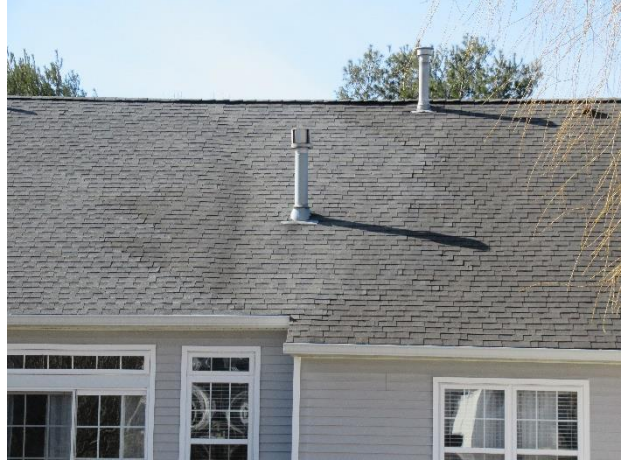
Condition: Fair overall with general asphalt shingle deterioration, stains and previous repairs evident. Management and the Board report a history of leaks over the past two years.

General asphalt shingle deterioration

Contractors use one of two methods for replacement of sloped roofs, either an overlayment or a tear-off. Overlayment is the application of new shingles over an existing roof. However, there are many disadvantages to overlayment including hidden defects of the underlying roof system, absorption of more heat resulting in accelerated deterioration of the new and old shingles, and an uneven visual appearance. Therefore, we recommend only the tear-off method of replacement. The tear-off method of replacement includes removal of the existing shingles, flashings if required and underlayments.

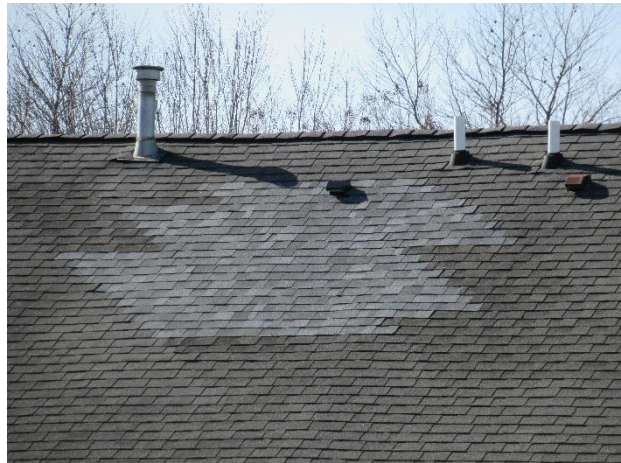
Previous repairs

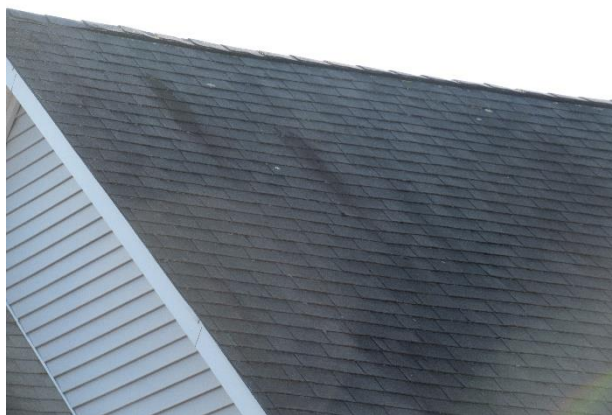
Asphalt shingle stains

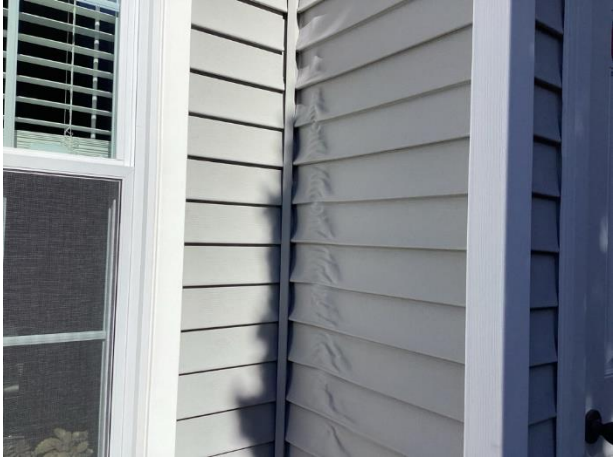
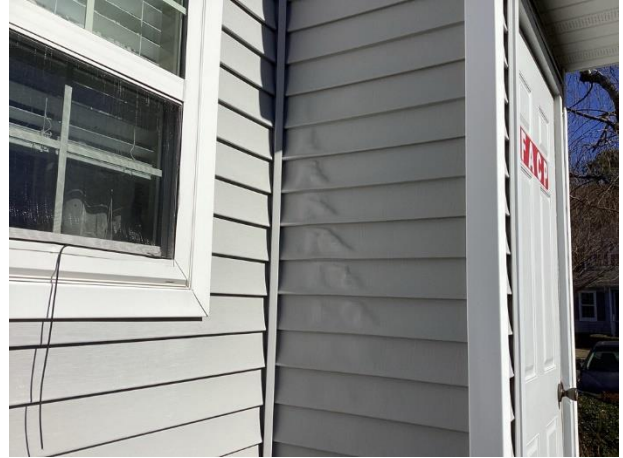
Condition: Good to fair overall with isolated areas of warp, primarily at the fire control panel rooms

Vinyl siding warp at fire control panel room

The Association should install new vinyl siding as recommended by the *Vinyl Institute, Inc.* The vinyl siding should be installed over a continuous weather resistant barrier and

properly integrated flashing around all penetrations. Fasteners used should include aluminum, galvanized steel or other corrosion-resistant fasteners. Siding panels should overlap by approximately one inch. Joints should be staggered so that no two courses are aligned vertically, unless separated by at least three courses. The siding should not be caulked where the siding meets trim accessories, such as J-channel, or at overlap joints. J-channel should be installed a minimum of ½ inch off of roof lines.

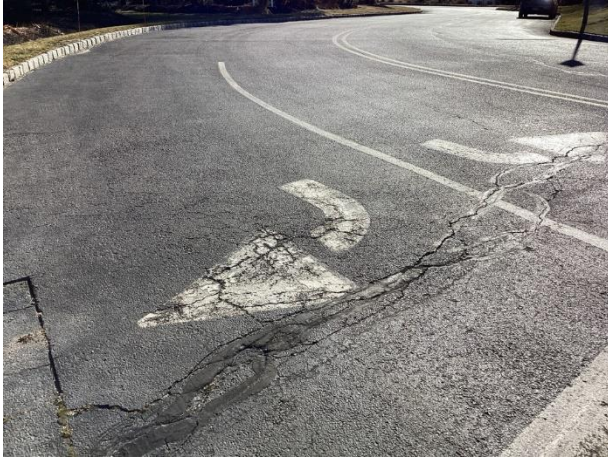
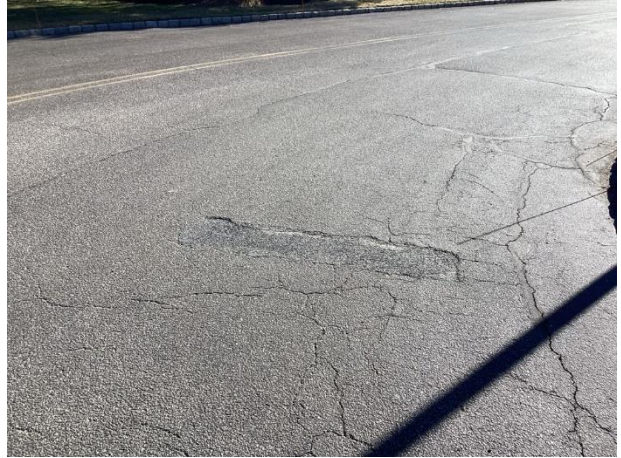
Conditions: The driveways are in good overall condition and the street and parking areas are in good to fair overall condition with general asphalt deterioration, cracks, stains and previous repairs evident.

Cracks at property entrance

The manner of repaving is either a mill and overlay or total replacement. A mill and overlay is a method of repaving where cracked, worn and failed pavement is mechanically removed or milled until sound pavement is found. A new layer of asphalt is overlaid atop the remaining base course of pavement. Total replacement includes the removal of all existing asphalt down to the base course of aggregate and native soil followed by the application of two or more new lifts of asphalt. We recommend mill and overlayment on asphalt pavement that exhibits normal deterioration and wear. We recommend total replacement of asphalt pavement that exhibits severe deterioration, inadequate drainage, pavement that has been overlaid multiple times in the past or where the configuration makes overlayment not possible. Based on the apparent visual condition and configuration of the asphalt pavement, we recommend the mill and overlay method for initial repaving of the streets and the total replacement method for driveway repaving and subsequent street repaving at Sterling Woods.

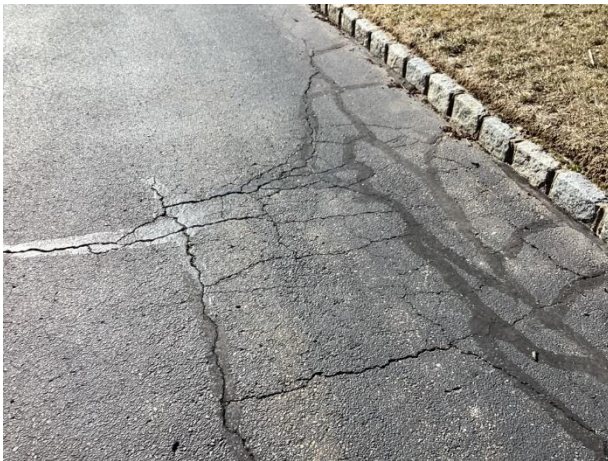
Cracks and previous repairs at street

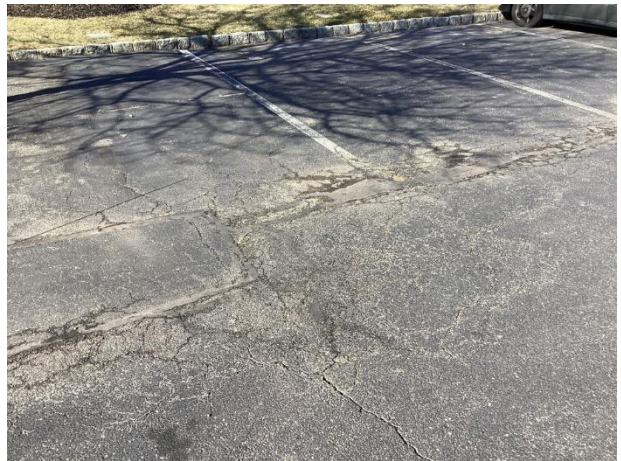
Cracks, stains and general deterioration at parking area

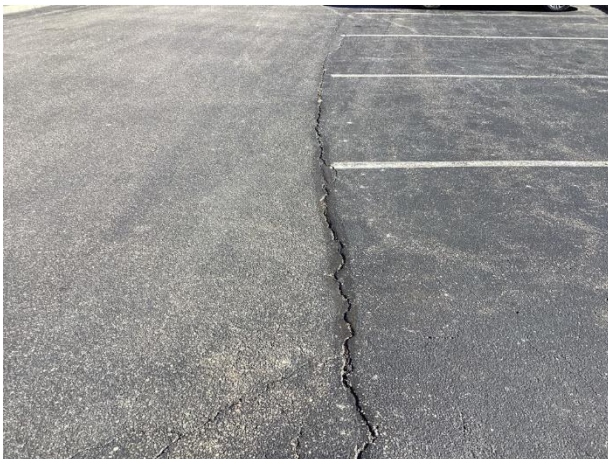
Crack between street and parking area

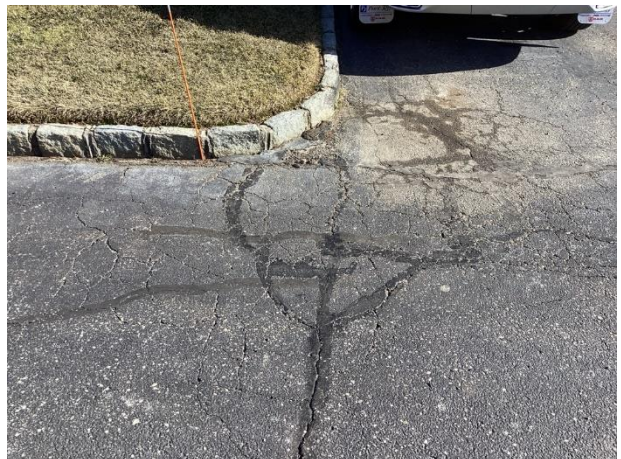
Cracks and previous repairs at parking area

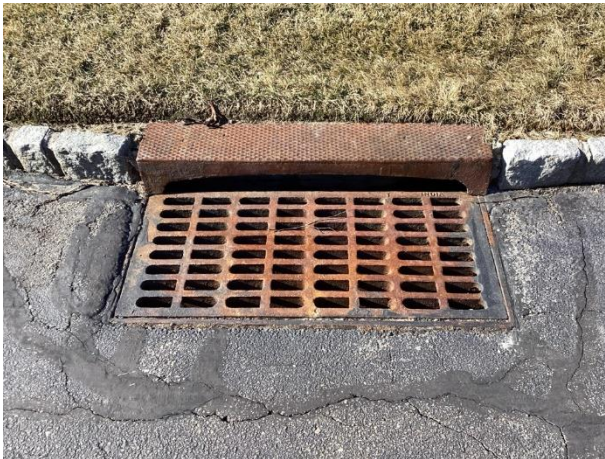
Previous repairs around catch basin

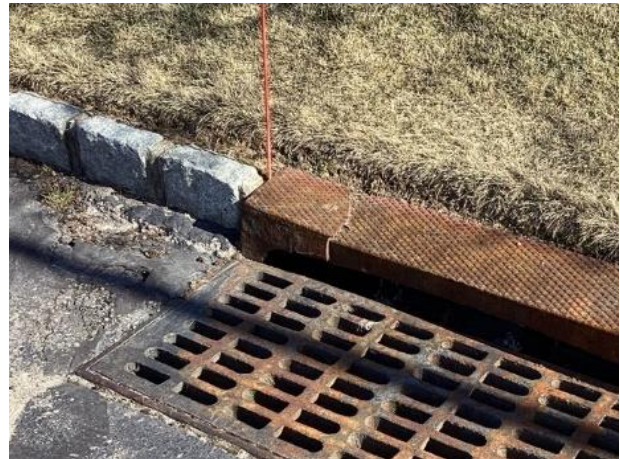
Condition: Good to fair overall with previous repairs and isolated damage evident at the catch basin grate by unit 28

Damage by unit 28

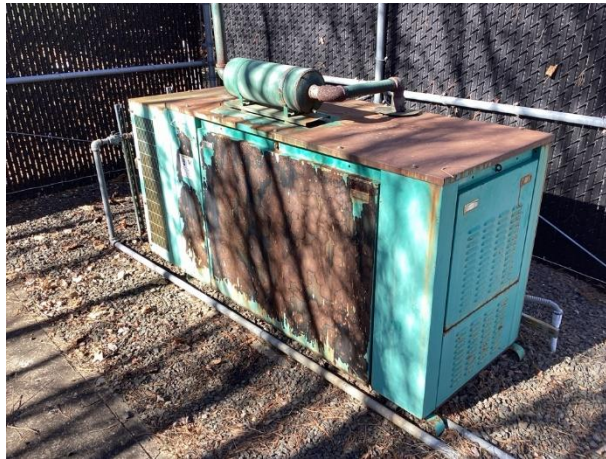
Condition: Reported satisfactory without operational deficiencies; we note significant rust at the generator housing.

**Generator overview
(note: significant rust)**

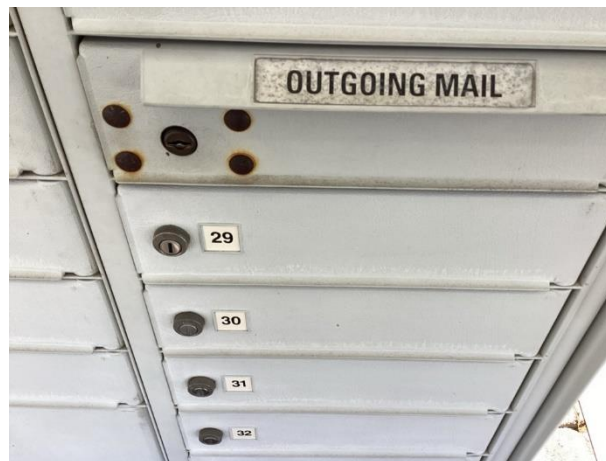
Condition: Good to fair overall with rust evident

Rust
