Sterling Woods, LLC

February 5, 2025 • Port Jefferson Station, NY

FULL RESERVE STUDY

Sterling Woods, LLC
Port Jefferson Station, New York

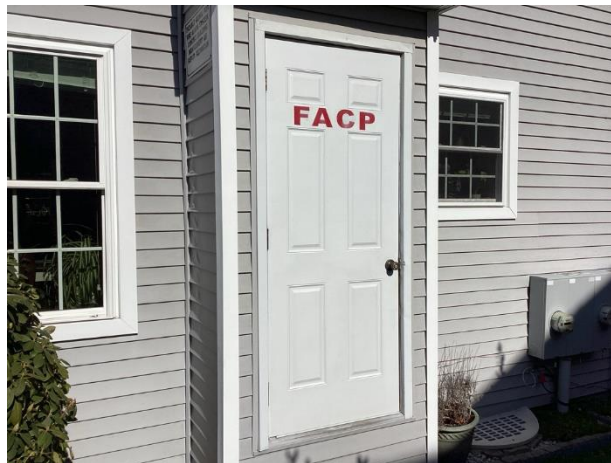
Condition: Good to fair overall

Typical fire control room door overview

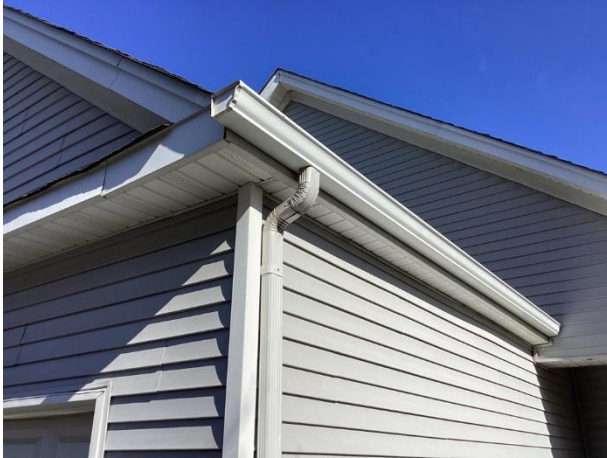
Condition: Good to fair overall with stains and general deterioration evident; Management and the Board report issues with the drainage capacity at the undersized gutters and downspouts.

Typical gutter and downspout overview

The Association should plan to coordinate the replacement of gutters and downspouts with the adjacent roofs. This will result in the most economical unit price and minimize the possibility of damage to other roof components as compared to separate replacements.

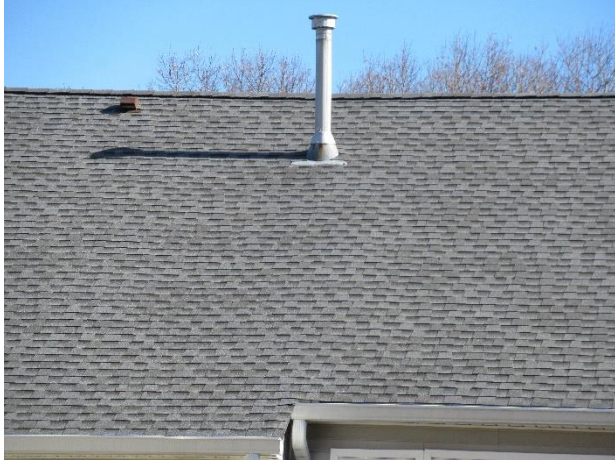
Condition: Fair overall with general asphalt shingle deterioration, stains and previous repairs evident. Management and the Board report a history of leaks over the past two years.

Asphalt shingle roof overview

Contractors use one of two methods for replacement of sloped roofs, either an overlayment or a tear-off. Overlayment is the application of new shingles over an existing roof. However, there are many disadvantages to overlayment including hidden defects of the underlying roof system, absorption of more heat resulting in accelerated deterioration of the new and old shingles, and an uneven visual appearance. Therefore, we recommend only the tear-off method of replacement. The tear-off method of replacement includes removal of the existing shingles, flashings if required and underlayments.

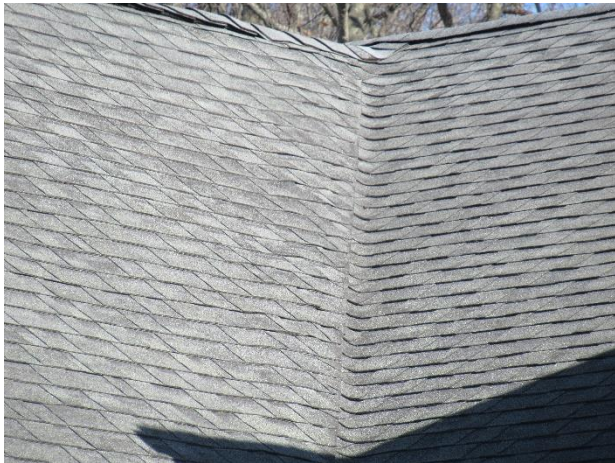
Example of enclosed half weaved valley

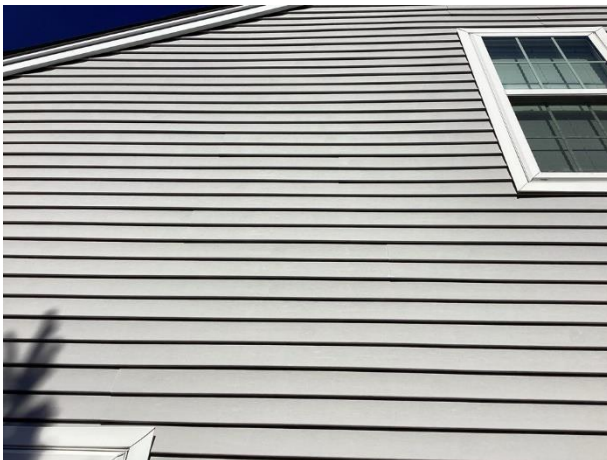
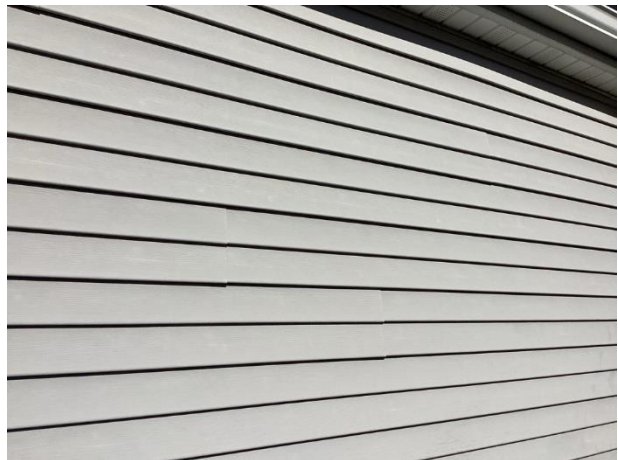
Condition: Good to fair overall with isolated areas of warp, primarily at the fire control panel rooms

Vinyl siding overview

The Association should install new vinyl siding as recommended by the *Vinyl Institute, Inc.* The vinyl siding should be installed over a continuous weather resistant barrier and

properly integrated flashing around all penetrations. Fasteners used should include aluminum, galvanized steel or other corrosion-resistant fasteners. Siding panels should overlap by approximately one inch. Joints should be staggered so that no two courses are aligned vertically, unless separated by at least three courses. The siding should not be caulked where the siding meets trim accessories, such as J-channel, or at overlap joints. J-channel should be installed a minimum of ½ inch off of roof lines.

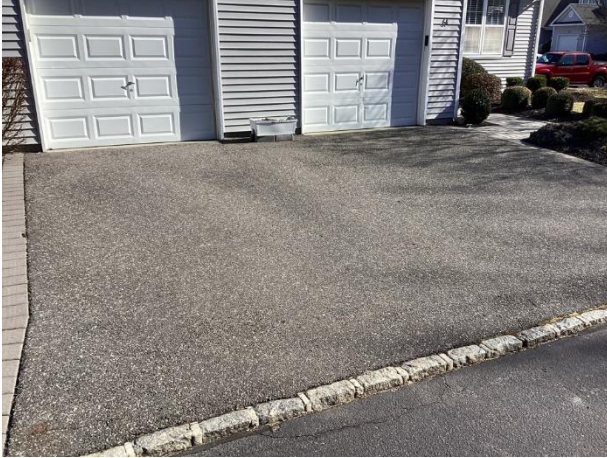
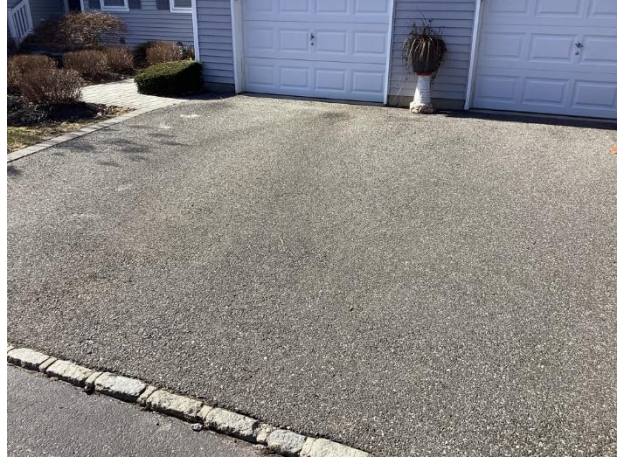
Conditions: The driveways are in good overall condition and the street and parking areas are in good to fair overall condition with general asphalt deterioration, cracks, stains and previous repairs evident.

Typical driveway overview

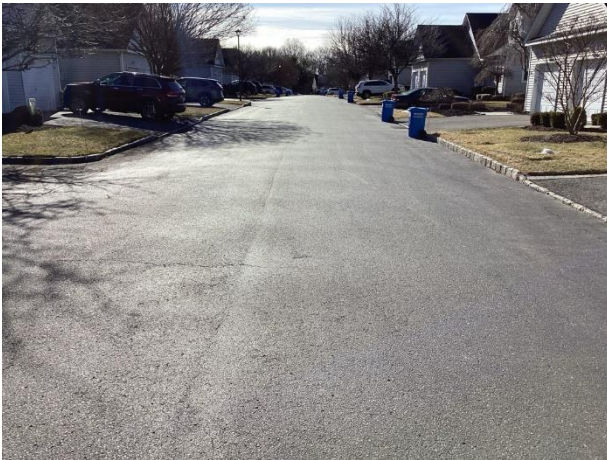
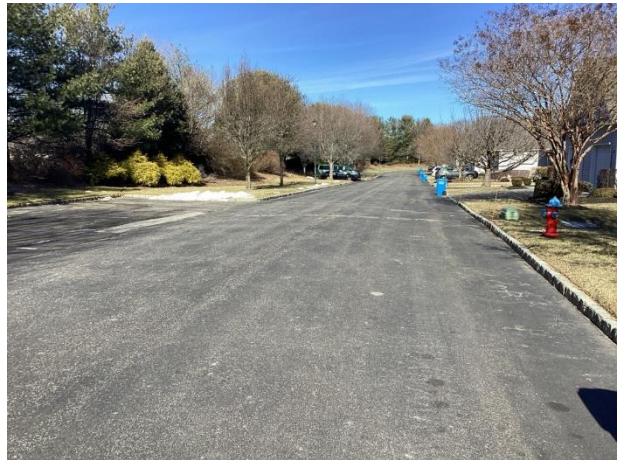
Asphalt pavement street overview

The manner of repaving is either a mill and overlay or total replacement. A mill and overlay is a method of repaving where cracked, worn and failed pavement is mechanically removed or milled until sound pavement is found. A new layer of asphalt is overlaid atop the remaining base course of pavement. Total replacement includes the removal of all existing asphalt down to the base course of aggregate and native soil followed by the application of two or more new lifts of asphalt. We recommend mill and overlayment on asphalt pavement that exhibits normal deterioration and wear. We recommend total replacement of asphalt pavement that exhibits severe deterioration, inadequate drainage, pavement that has been overlaid multiple times in the past or where the configuration makes overlayment not possible. Based on the apparent visual condition and configuration of the asphalt pavement, we recommend the mill and overlay method for initial repaving of the streets and the total replacement method for driveway repaving and subsequent street repaving at Sterling Woods.

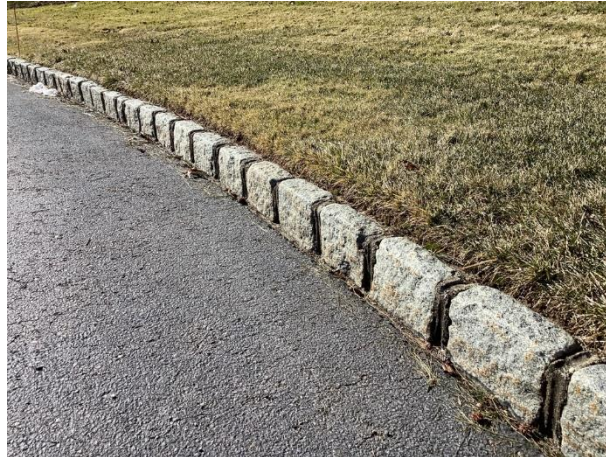
Condition: Good overall

Granite curbs overview

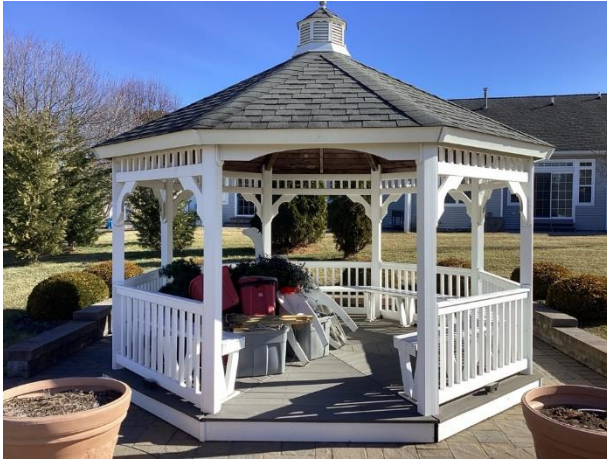
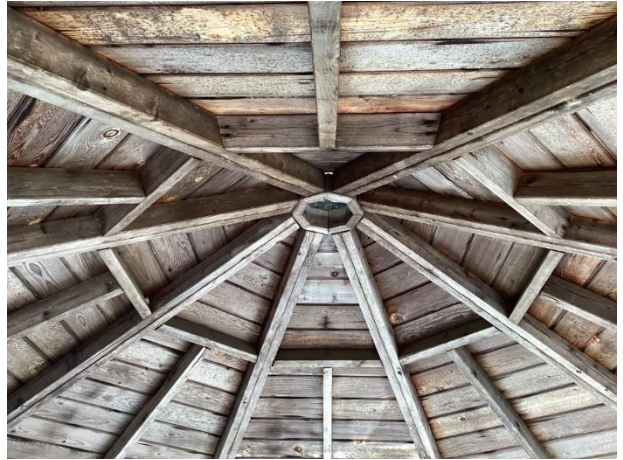
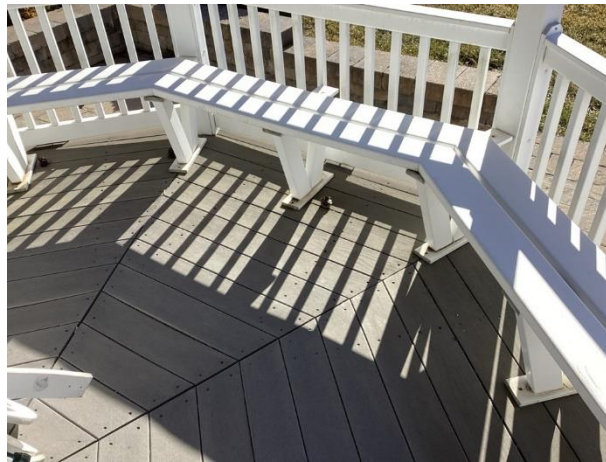
Condition: Good to fair overall

Gazebo overview

Roof underside overview

Railings, benches and deck boards overview

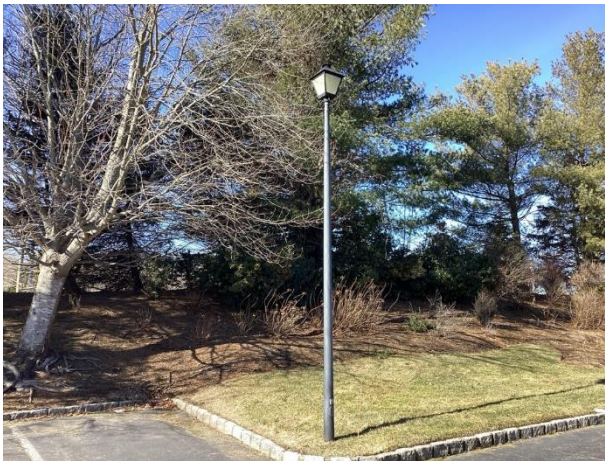
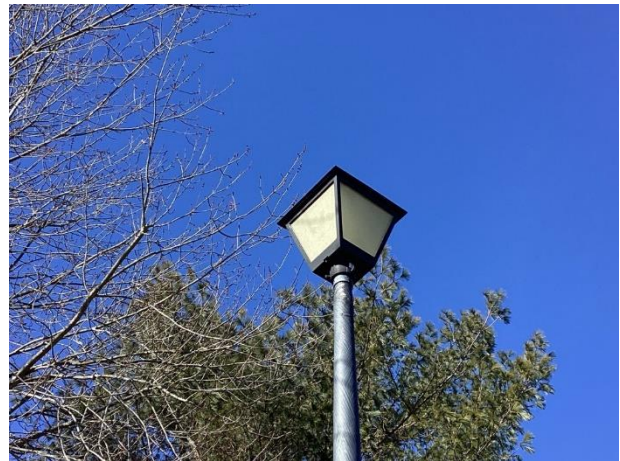
Condition: Good to fair overall

Typical light pole and fixture overview

Typical light fixture overview

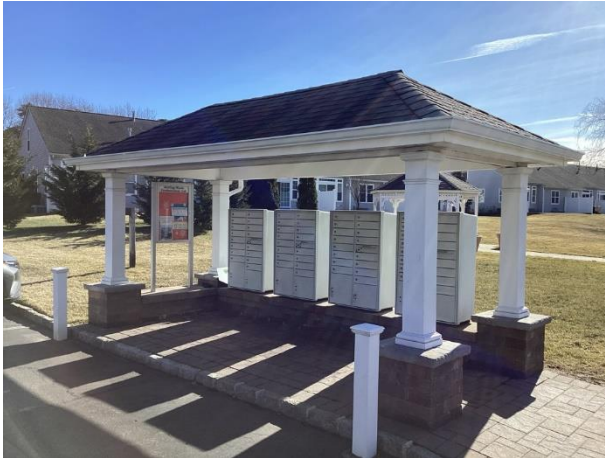
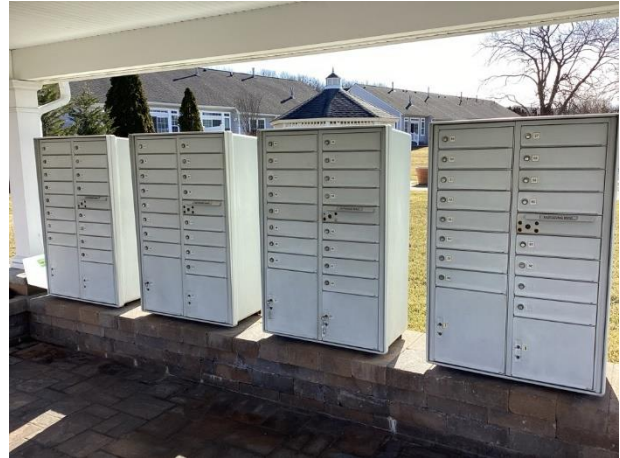
Condition: Good to fair overall with rust evident

Mailbox station kiosk overview

Mailbox stations overview

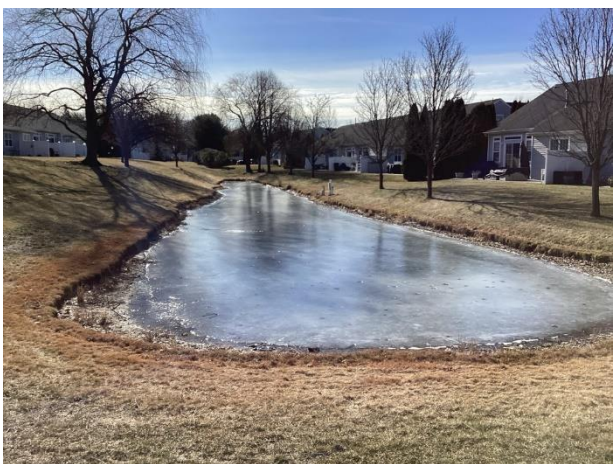
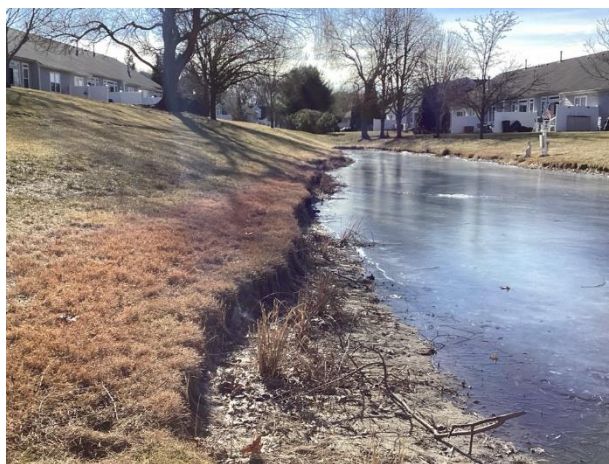
Condition: Good to fair overall

Pond overview

Shoreline overview

Useful Life: Based on the visual condition and construction, we recommend the Association anticipate the need to remove pond sediment up to every 30 years.

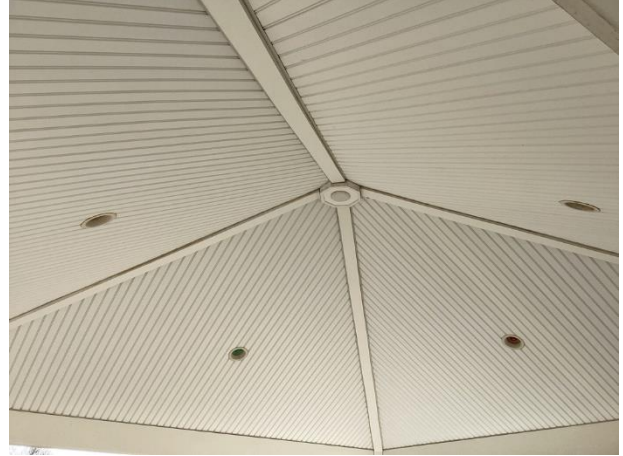
Condition: Good overall

Roof underside overview

- Annually:
 - Inspect for wood deterioration, and loose or missing fasteners
- Every three years:
 - Power wash with algaecide and application of sealer/stain

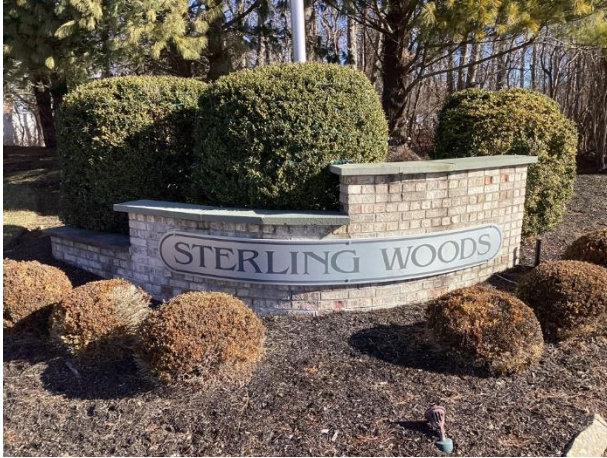
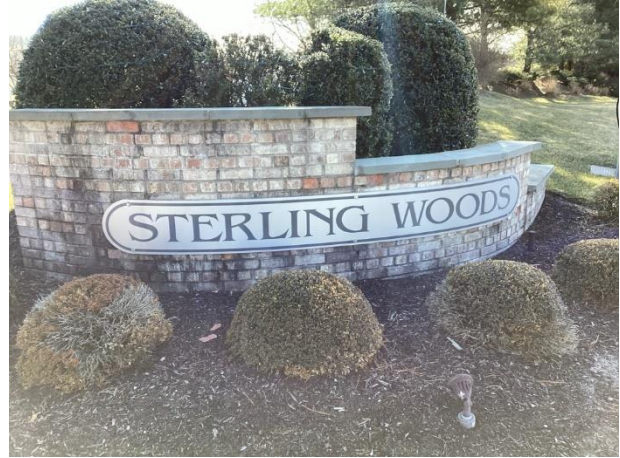
Condition: Good to fair overall with stains and brick masonry deterioration evident

Community identification signage overview

- Annually:
 - Inspect and repair damage, vandalism and loose components
 - Verify lighting is working properly
 - Touch-up paint finish applications if applicable

Expenditure Detail Notes: Expenditure timing and costs are depicted in the **Reserve Expenditures** table in Section 3. Our cost for renovation includes repairs to the brick masonry walls and replacement of the remaining components listed above.
